# Manhole Inspection Summary

Manhole # S41UU\_017MH

Insp Date: **2/23/07 9:03 AM**

**Location** Address: **2654 KIRK AVE**

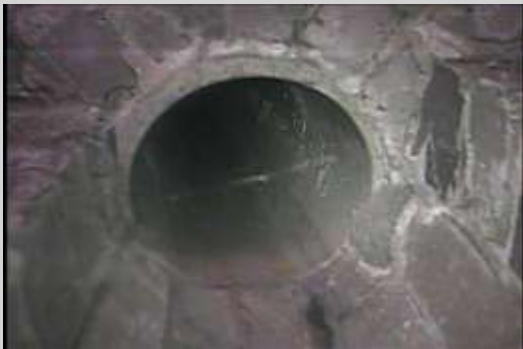
### 8 in. Circular Gravity Sewer Pipe In @ 3 O'Clock

Rod and Bar (Angled)

Infiltration: **None** Pipe Seal Cond: **Unknown**
